21	·	
22	Granting Application for Stay and Early Mediation," filed February 12, 2019, the plaintiff submits his Plaintiff's Case Statement.	
23	the plaintiff submits his Plaintiff's Cas	se Statement.
24	A. Itemized List	
25		
26	The specific conditions at the site that forms the basis of this lawsuit are	
27	the lack of accessible ticket dispenser, point-of-sale machine, check-writing	
	surface, route of travel and restroom facilities at the Jimenez Ranch Market	
28	("Market") located in Pomona, California.

2526

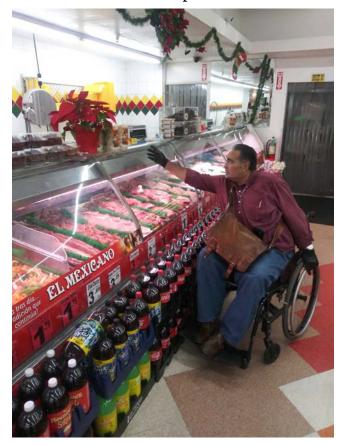
1. Inaccessible Ticket Dispenser:

- ❖ Where a clear floor or ground space allows a parallel approach to an element and the high side reach is over an obstruction, the height of the obstruction shall be 34 inches maximum and the depth of the obstruction shall be 24 inches maximum. The high side reach shall be 48 inches maximum for a reach depth of 10 inches maximum. Where the reach depth exceeds 10 inches, the high side reach shall be 46 inches maximum for a reach of 24 inches maximum. 2010 Standards § 308.3.2.
- ❖ Here, the meat department ticket dispenser was in excess of the heights allowed by law.
- The included photo of the Facility depicts the above violation.

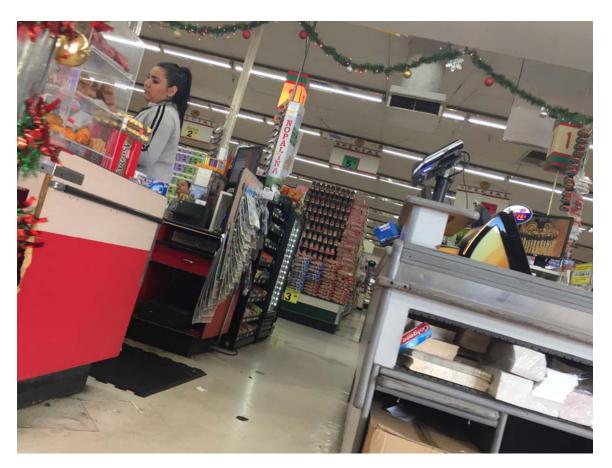
2. Inaccessible Point of Sale Machine:

- ❖ Under the ADA, when a place of public accommodation offers a facility, privilege, or advantage to its customers, it must offer full and equal enjoyment of the same to persons with disabilities. 42 USC 12182(a).
- ❖ Here, the electronic point of sale machine made available to customers is a distinct facility, privilege or advantage and, therefore, must be accessible to persons with disabilities also.
- ❖ While there is no explicit access standard for "point of sale machines," the most analogous standard for display screens on such devices is found at section 707.7.1 of the 2010 Standards. Under that standard, the display screen must be visible from a viewpoint 40

inches above the floor. The California Building Code (CBC) is more explicit, directly addressing point of sale machines.

- ❖ Since the 1995 version of the CBC—and continuing to this date point of sales machines were required to be accessible to persons with disabilities. Under the CBC, where point of sale machines are provided at the accessible check stands, sales or service counters, the display screen must be visible from a viewpoint 40 inches above the floor. If the display screen is mounted vertically (or tipped away from the viewer less than 30 degrees) the center line of the display screen shall not be more than 52 inches above the floor. 11B-707.7.1.1. If the display screen is angled or tipped away from the viewer by more than 30 degrees but less than 60 degrees, then the center line of the display screen shall not be more than 44 inches above the floor. 11B-707.7.1.2. Finally, if the display screen is mounted horizontally (or tipped away from the viewer by more 60 degrees) then then the center line of the display screen shall not be more than 34 inches above the floor. This has been the accessibility standard in all versions of the CBC since 1995.

- ❖ In the 1995 CBC, that standard as found at section 3105A(g)5. In the 1998 through 2013 versions of the CBC, that standard was found at section 1117B.7.5. Currently, that standard is found at section 11B-707.7.1.

- ❖ By failing to provide an accessible point of sale machine, the defendants have violated the law.
- ❖ The included photo of the Facility depicts the above violation.

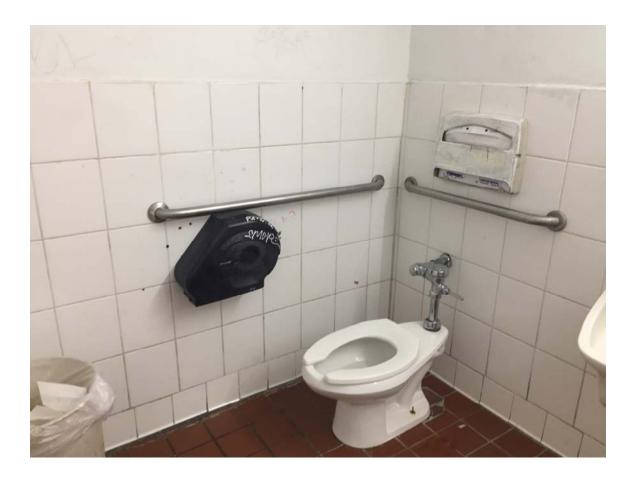
5. Lack of Accessible Grab Bar:

- ❖ Grab bars at the toilet must be mounted between 33 and 36 inches in height. 2010 Standards § 609.4.
- ❖ Here, the failure to ensure that the grab bars were mounted within the range required by the ADA is a violation of the law.
- ❖ The included photo of the Facility depicts the above violation.

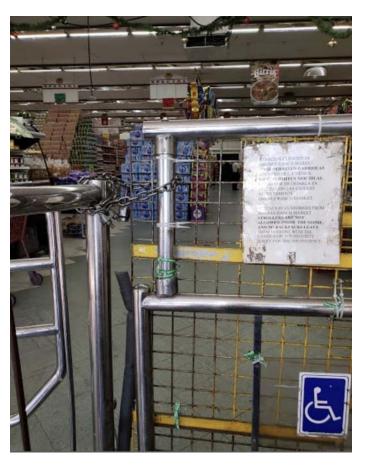
7. Inaccessible Route of Travel:

- ❖ Accessible routes shall coincide with or be located in the same area as general circulation paths. Where the circulation paths are interior, required accessible routes shall also be interior. 2010 Standards §206.3.
- ❖ Here, even though ambulatory customers can immediately enter the sales floor upon entering the Market, persons with disabilities who are in wheelchairs are not able to do so because the defendants keep the swinging gate located next to the turnstile locked.
- The included photo of the Facility depicts the above violation.
